Manhole Inspection Summary

Manhole # S27O1_006MH

Insp Date: **4/9/08 9:10 AM**

Location Address: **2800 Sethlow Rd. (cherry hill maintenance office)**

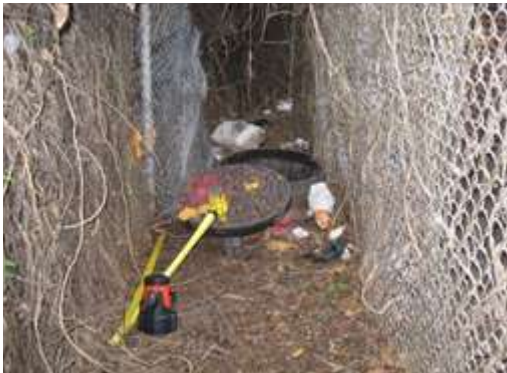
Location View

Cherry Hill Maintenance Office (between two fences)

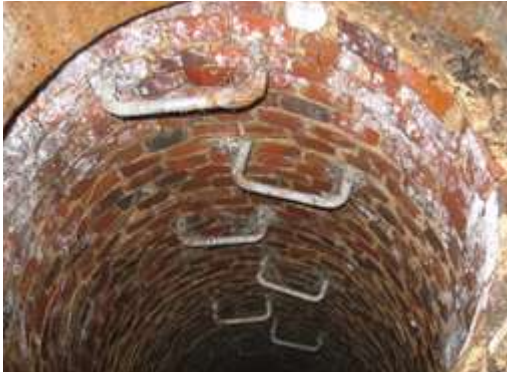
Steps Count: **8** Missing: **0** ☒ **Corroded**

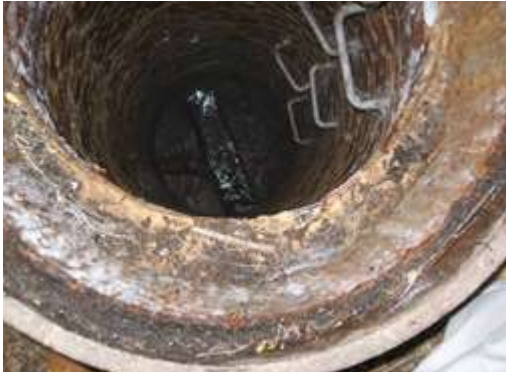
Defect 1

Frame Offset: **5** (in.) Condition: ☒ Sound ☐ Cracked ☐ Leaks

Frame offset

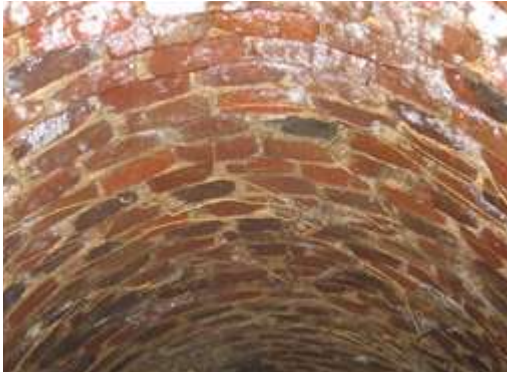
Defect 2

Infiltration: ☐ None ☐ Joint ☐ Cracks ☐ Mortar ☒ **Roots** ☐ Wall

Roots

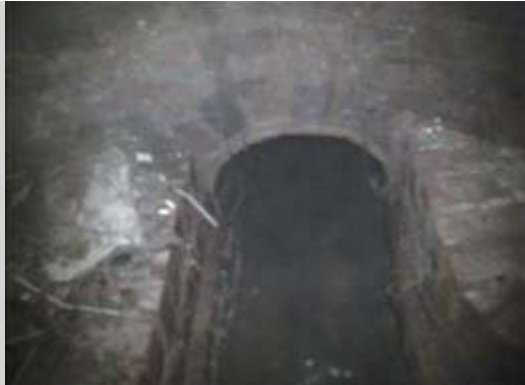
12 O'Clock Outflow

12 in. Circular Gravity Sewer
Pipe Out @ 12 O'Clock

Pipe Height: **12** (in.) Rod and Bar (Angled)
Pipe Material: **Clay** ☐ Pipe Lined
Invert Depth: **16.00** (ft.) Flow Characteristics: **Fast**
Deposits: ☒ None ☐ Mud ☐ Sludge ☐ Debris ☐ Grease
Silt Depth: (in.) Deposits Extent:
Infiltration: **None** Pipe Seal Cond: **Sound**

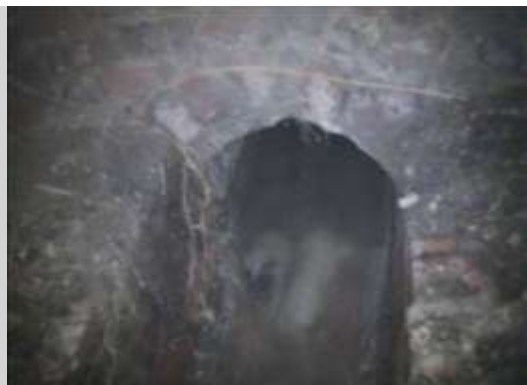
6 O'Clock Inflow

12 in. Circular Gravity Sewer
Pipe In @ 6 O'Clock

Pipe Height: **12** (in.) Rod and Bar (Angled)

Pipe Material: **Clay** ☐ Pipe Lined

Invert Depth: **16.00** (ft.) Flow Characteristics: **Fast**

Infiltration: **None** Pipe Seal Cond: **Sound**
